Asesiad Diweddaru a Sgrinio 2015 ar gyfer

Cyngor Sir Caerfyrddin

Er mwyn cyflawni Rhan IV o Ddeddf yr Amgylchedd 1995 Rheoli Ansawdd Aer Lleol

(Mehefin, 2015)

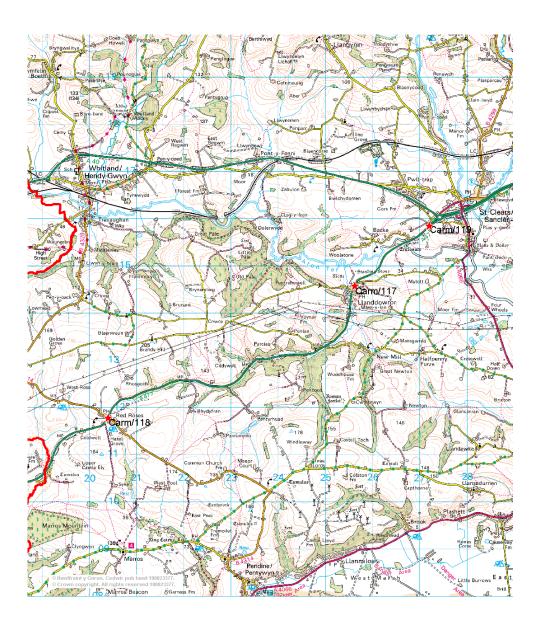
Appendix 1 – Diffusion Tube Location Map

Locations for Carm/117, Carm/118 and Carm/119

Please note that maps illustrating the locations of most of the diffusion tube sites have not been included in the section. All current site locations have either previously been identified in other recently submitted reports or are contained in Appendices of this report. The exception to this is the two new tube sites that have been located along Sandy Road in Llanelli. Figure 2.1 below illustrates the locations of the eight diffusion tubes associated with Sandy Road, which includes the two new sites. The inclusion of maps illustrating the rest of the tube locations spread across the county would unnecessarily greatly lengthen this report.

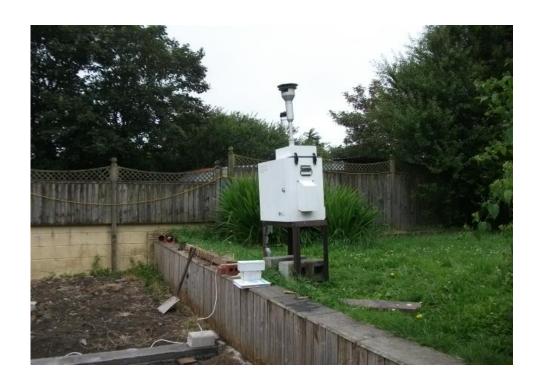
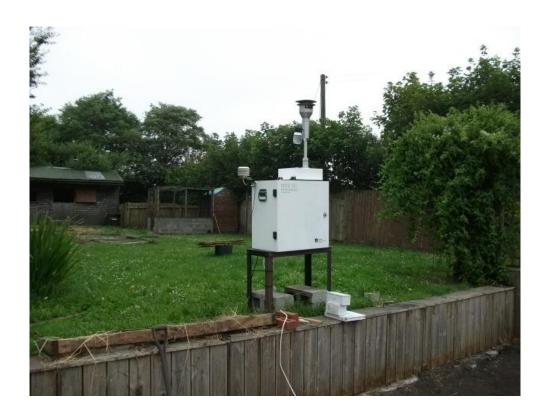
PM10 Partisol Sequential Air Sampler

2.1 The study used a Rupprect and Pataschnick Partisol-Plus 2025 sequential sampler to sample for PM_{10} Particulates (illustrated below).

The Partisol – Plus 2025 has an automatic filter changing system, which collects particulate matter of $10\mu m$ in diameter onto 47mm diameter quartz fibre filters. A capacity of up to 16 filters can be stored in the re-usable cassette magazines. The filters are pre-conditioned for 48 hours before weighing in an air conditioned weighing room with a temperature of 20 ± 1 °C. The filters are weighed pre and post exposure, and the mass of material collected over the monitoring period (24h) is calculated. The filters were also examined for pinholes and other imperfections prior to sampling.

- 2.2 The Sequential sampler was operated in accordance with the manual. It does not require calibration however it was necessary to check the flow rate and also clean the sample inlet head before sampling. The Sampler also recorded filter data and total sample flow and it made automatic corrections for ambient temperature and pressure.
- 2.3 The study ran from 4th July 2014 until 29th September 2014, a period of three months (88 days). However, there was a complete power failure on the 30th August resulting in failed filter changeovers which meant that two days data loss occurred. Therefore, the reported data set has been reduced by 2 days and the assessment is based on 86 days of sampling.
