Adroddiad Cynnydd 2014 ynghylch
Ansawdd Aer ar gyfer
Cyngor Sir Caerfyrddin

Er mwyn cyflawni Rhan IV o
Ddeddf yr Amgylchedd 1995
Rheoli Ansawdd Aer Lleol

Tachwedd, 2014

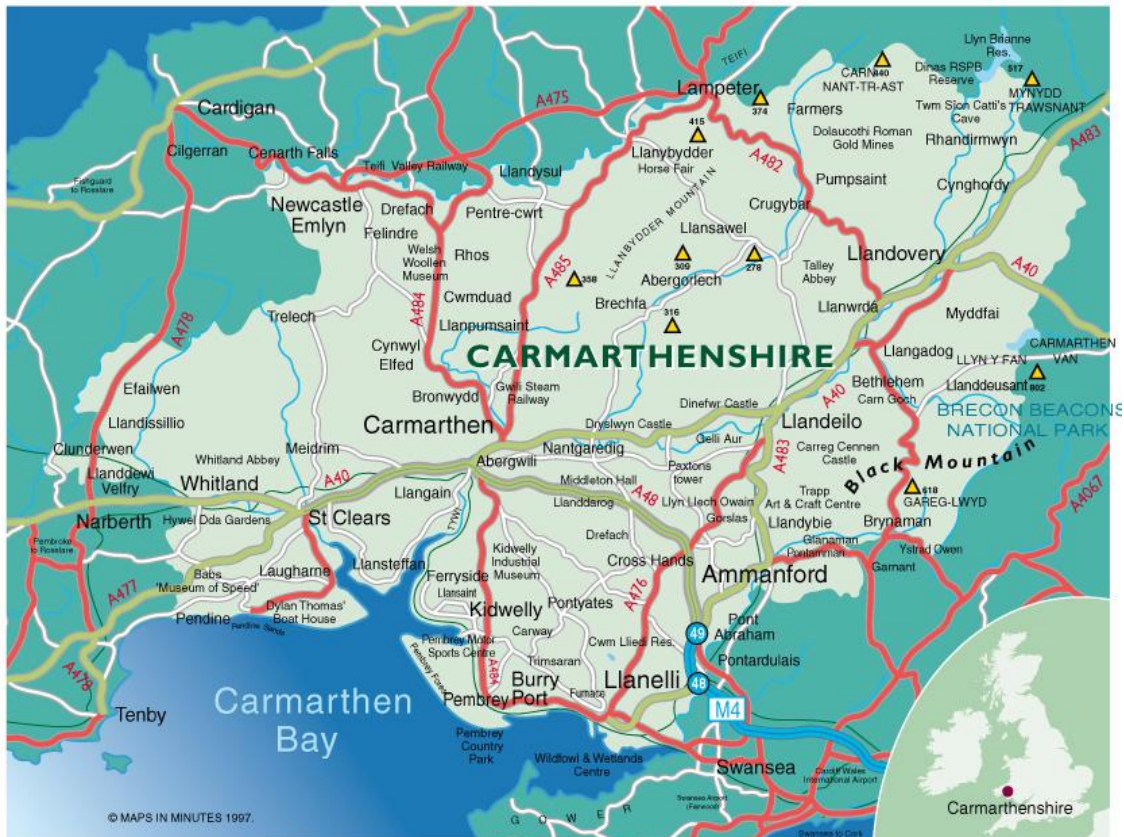
Figure 1.0 Principal Geographical Features of Carmarthenshire

Several principal pollution sources, which may be of importance to the assessment of several individual pollutants, may be identified within Carmarthenshire. The locations of industry, principal road traffic routes, busy road junctions and railways are of particular importance.

Carmarthenshire County Council was formed as a unitary authority in April 1996. The County is one of the largest in Wales, being predominantly rural with the industrial town of Llanelli to the south somewhat of a contrast to other areas of the authority. The population of over 170,000 is concentrated in the towns of Llanelli, Carmarthen, Ammanford, and Llandeilo. Tourism focuses on Carmarthenshire's 70 miles of coastline (including the new Millennium Coastal Park), the Brecon Beacons to the North East and the National Botanic Garden of Wales. The principal features of the County are illustrated in Figure 1.0.

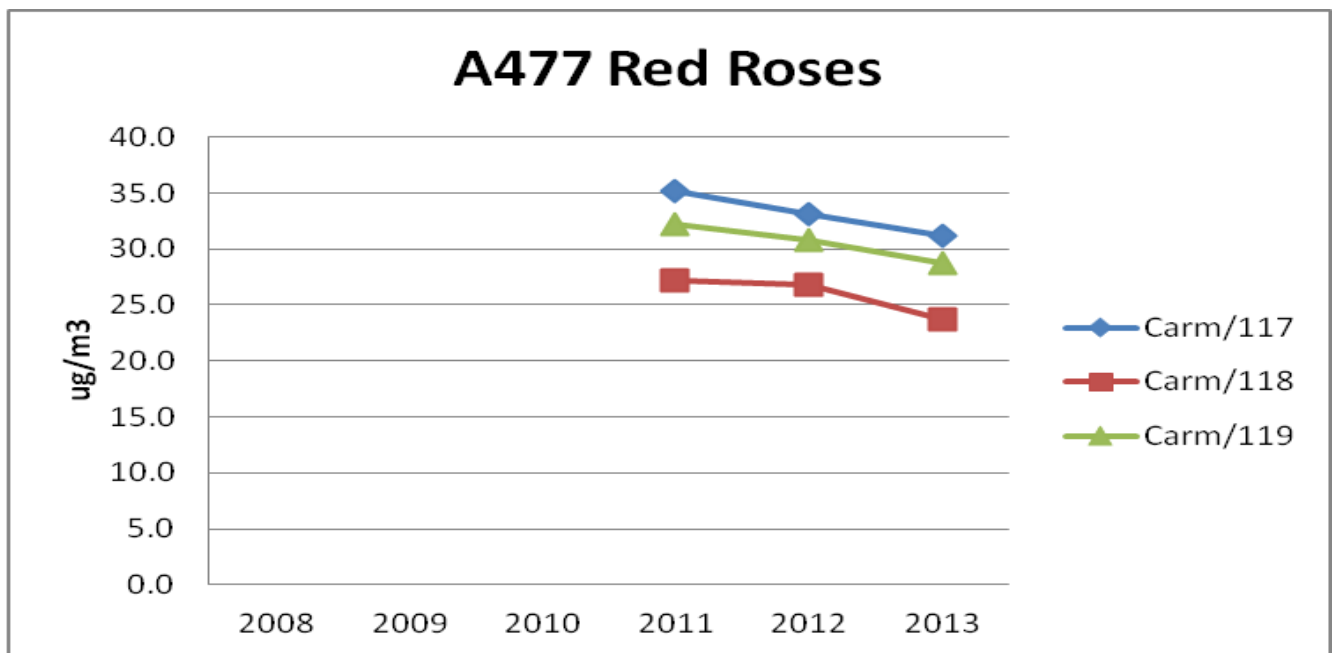
Figure 2.4b Annual Mean NO₂ Trend Graph (A477 Red Roses)

Figure 2.4b below provides the trends for the A477 diffusion tubes that were set up to assess the impact from the Red Roses Relief Road project. The results for the tubes last year was somewhat surprising as it was expected that the results would increase as the project progressed and that there would potentially be significant congestion associated with the works being carried out. However, the impacts on traffic flow were relatively minimal during 2013 and this is perhaps testament to the contractors implementing the project.

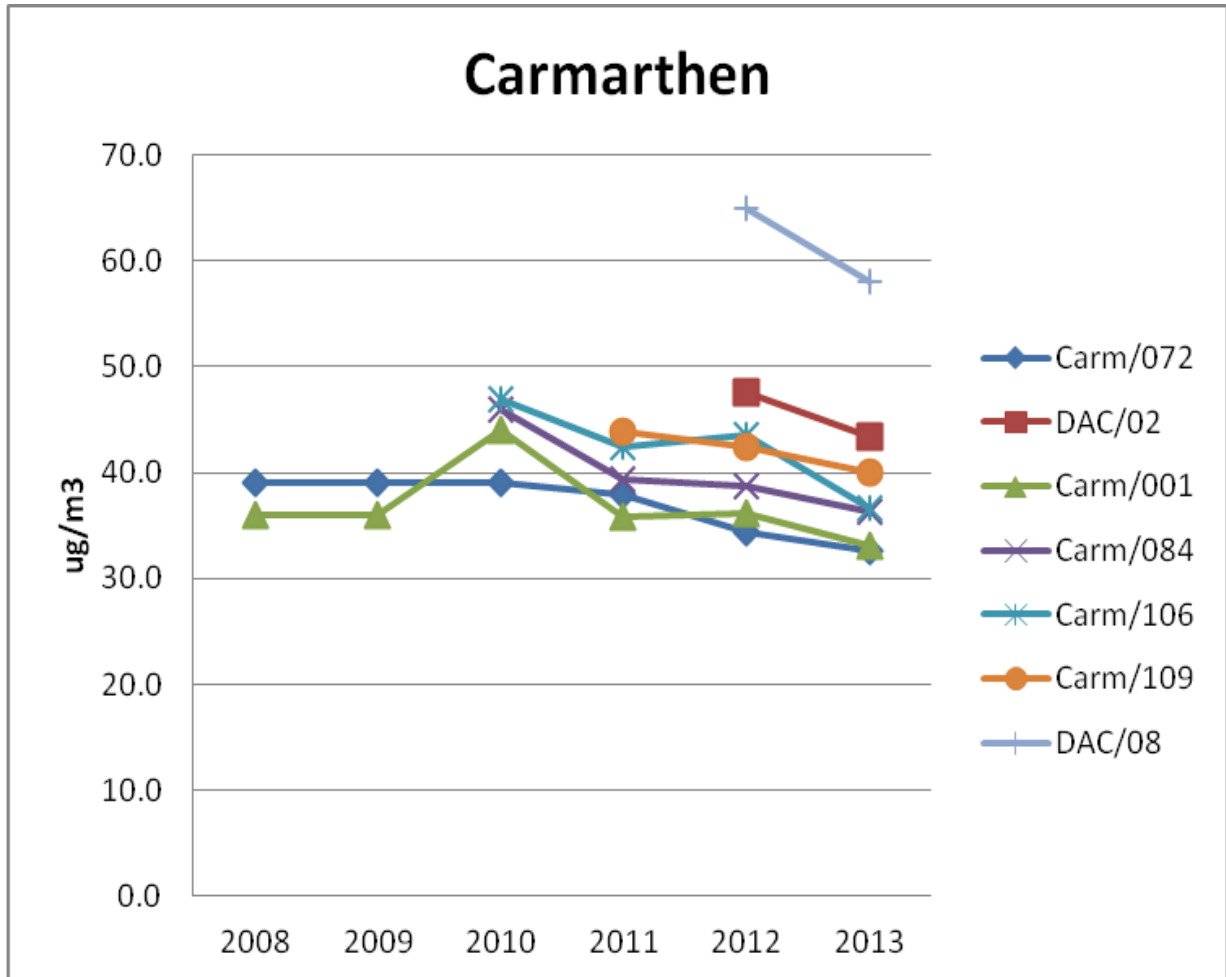
Figure 2.4c Annual Mean NO₂ Trend Graph (Carmarthen)

The graph below in Figure 2.4c shows the main diffusion tube sites associated with the town of Carmarthen. The two historical tubes, St Catherine Street rdbt (Carm/072) and St Catherine Street (Carm/001), display a slight downward trend and are below the AQO. However, the two sites associated with the Detailed Assessment, 85 Priory Street (E) (DAC/08) and 15 Park Terrace (DAC/02), are both above the AQO. All of the sites for Carmarthen display a downward trend but this may be misleading as 2013 was an exceptionally wet year.

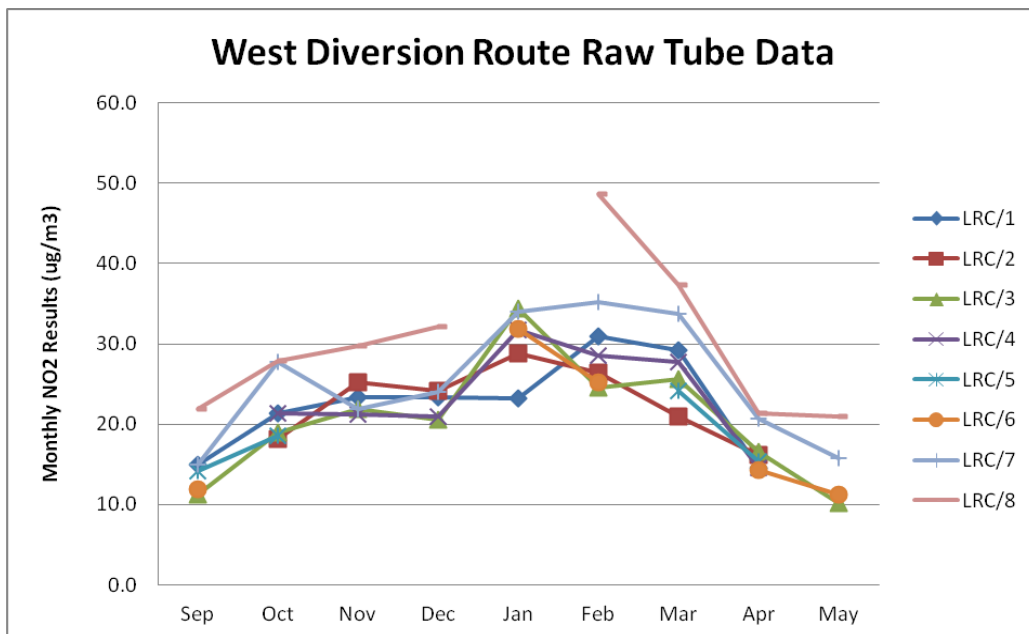
Figure 3 – Monthly Raw NO₂ Results (West Diversion Route)

Below are a series of graphs illustrating the data that has been presented in Tables 3 and 4 shown above. Figure 3 shows the raw monthly results and Figure 4 presents the averaged data for the West diversion route. Figures 5 and 6 present the information relating to the East diversion route.

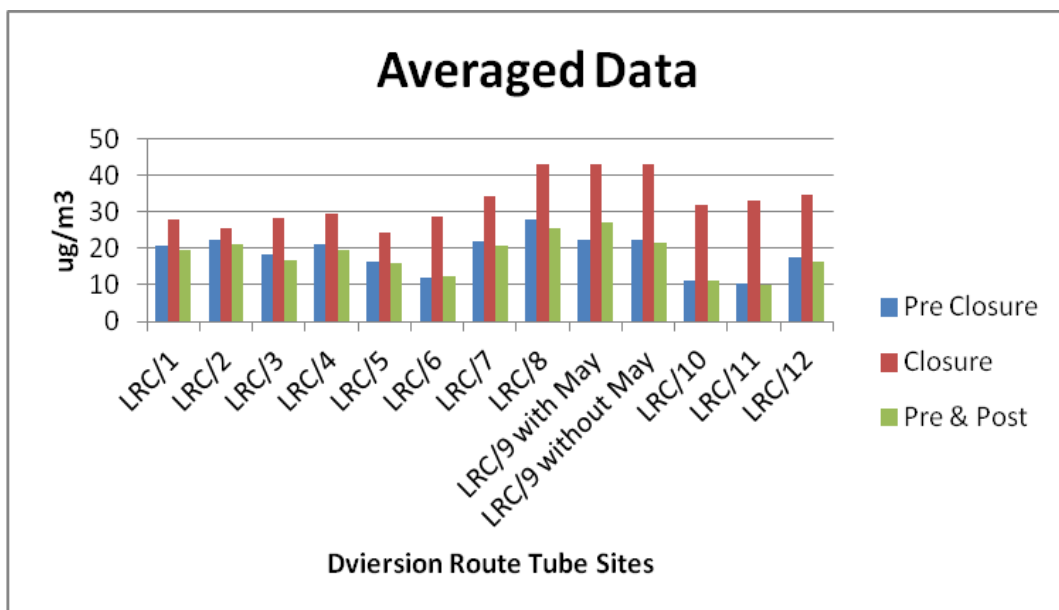
Figure 7 - Averaged NO₂ Results (including Pre & Post)

Taking a step further the averaged data can be combined on one graph, Figure 7 below, and then illustrates that for the majority of the sites the pre and post combined average data is lower than the pre closure averages on their own effectively increasing the 'gap' between the closure average and 'normal' situation.

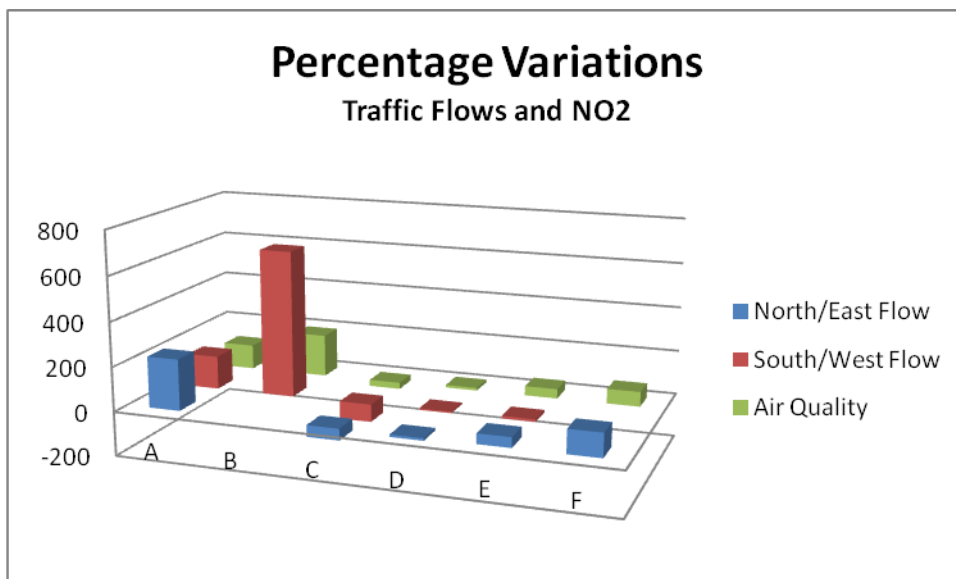
Figure 9 – Percentage Variations

Location	Percentage Change		
	North/East Flow	South/West Flow	NO ₂
A – (LRC/12)	231	150	112
B – (LRC/10)	-	659	192
C – (DA/13)	-52	-80	-29
D – (DA/01)	-11	6	12
E – (LRC/1)	46	11	43
F – LRC/8)	106	-	67
