**ARCHWILIAD**  
**CYNLLUN DATBLYGU LLEOL DIWYGIEDIG**  
**SIR GAERFYRDDIN (2018-2033)**

**Sesiwn Gwrandawriad 8 – Pobl a Lleoedd Ffyniannus – Dyraniadau Safle (Clwstwr 2 – Llanelli)**

**DORMOUSE NEST TUBE SURVEY**  
**(ADDENDUM TO PRELIMINARY ECOLOGICAL APPRAISAL, AUGUST 2015)**  
**at**  
**HEOL PLAS ISAF, LLANGENNECH.**

**Extended Phase 1 Habitat Survey**  
**on**  
**Land at Heol Plas Isaf, Llangennech**

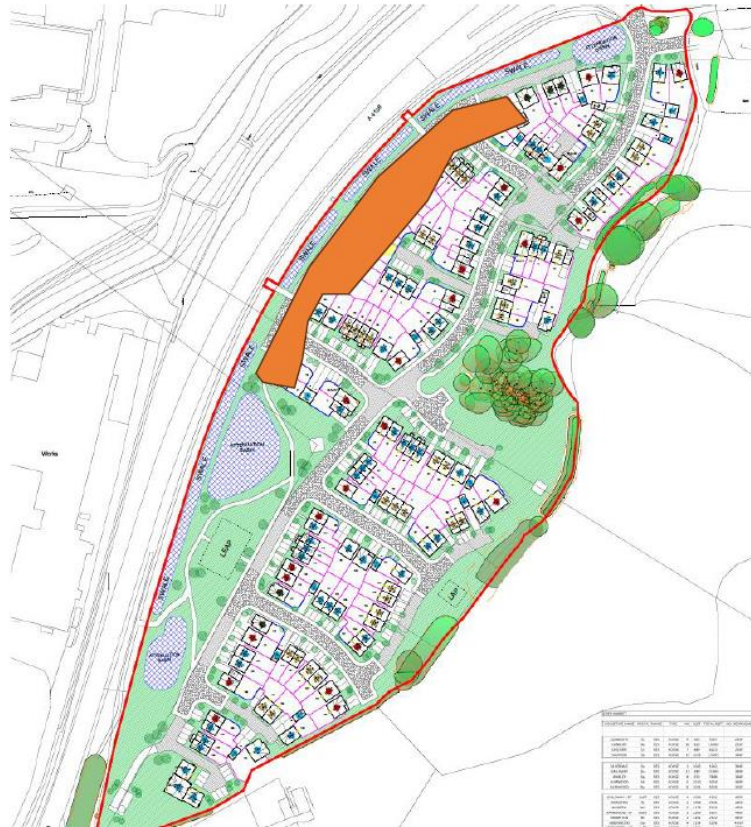
The refusal refers to 62 dwellings which fall within Noise Exposure Category C of TAN 11, however the scheme proposes a range of noise mitigation measures which would bring a considerable number of the proposed dwellings into an acceptable range. Following consideration of the refusal, our Noise Consultants (Hunter Acoustics) have advised that to comply with Carmarthenshire's comments we may need to lose the following plots off the submitted layout – 29, 30, 39-49 and possibly 71 and 72. This would crudely remove the below from the net developable area.

We will therefore be working on an amended layout to maximise density and unit numbers with the removal of the highlighted section from the developable area. We will strive to achieve similar unit numbers to those achieved in the refused application.

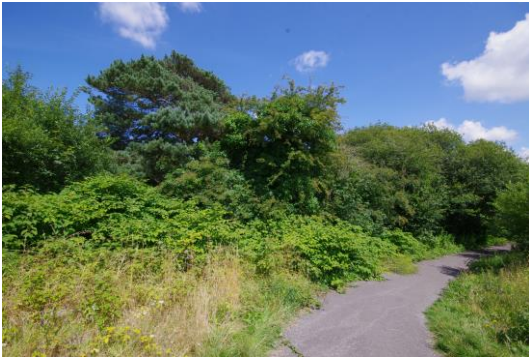
Photo 1: Southern boundary, showing spread of Knotweed

Japanese Knotweed (*Fallopia japonica*) was recorded on the site in several areas. These are well-established stands and are mainly located along the southern and central parts of the site, probably associated with easy access from the footpaths. A smaller area was noted in the north-west area of the site.

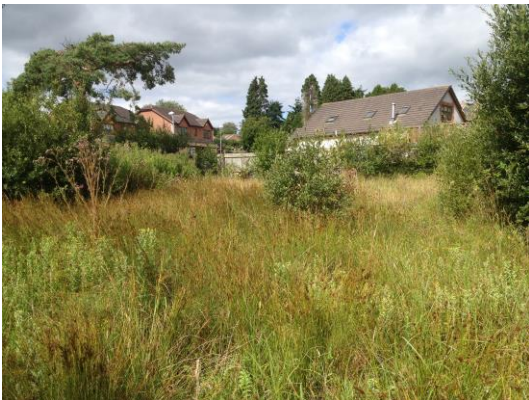
Photo 2: SE corner – scrub encroaching on grassland

These areas are fairly rank in nature and affected by scrub encroachment (Willow and Bramble), Bracken (*Pteridium aquilinum*) and garden escapees. Species noted included grasses such as Cock's-foot (*Dactylis glomerata*), Yorkshire fog (*Holcus lanatus*), Fescue sp (*Festuca sp*) and Sweet Vernal (*Anthoxanthum odoratum*). Forbs include Silverweed (*Potentilla anserina*), Common Fleabane

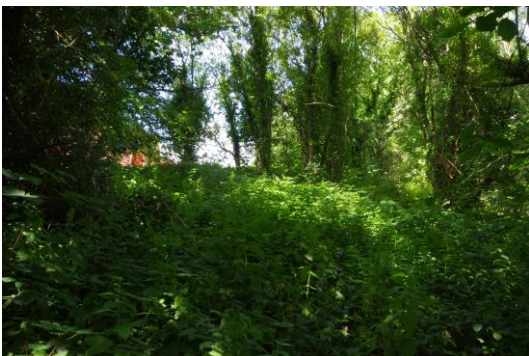
Photo 4: Typical woodland in northern area

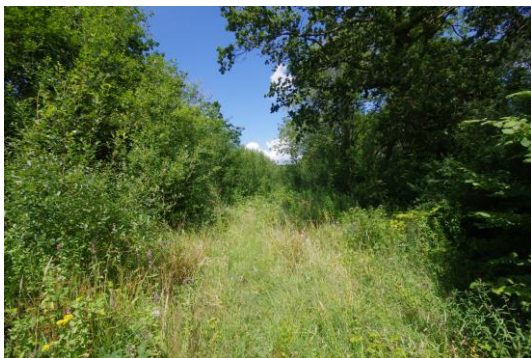
**Photo 7: Open area along sewage pipe route**

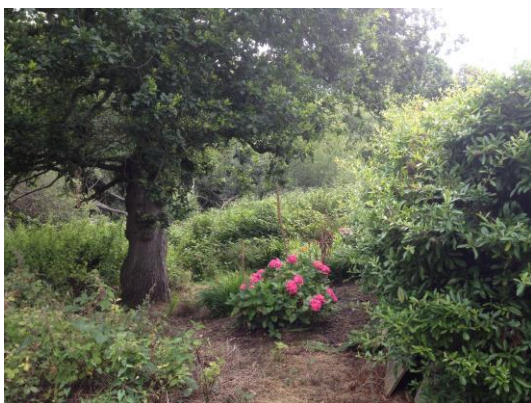
**Photo 8: Mature oak (T1) with garden area**

Tree Location	Description	Evidence of Bats	Potential for Bats	Retain (✓) or Remove (x)
T1	Mature Oak on corner of no 19. DBH 2.3m. Includes holes, crevices, loose bark and broken branches.	None	High	✓
T2	Semi-mature Oak, leaning. DBH 1.0m. Ivy clad.	None	Low	X
T3	Young Oak, suppressed. DBH 0.6m.	None	Low	X
T4	Coppiced Oak. 1.2m DBH. Multi-stemmed from approx. 2m. Some die-back.	None	Moderate	✓ (Review later)
T5	Young oak. Suppressed. DBH 1.0m	None	Low	X
T6	Young Ash, leaning. DBH 0.9m	None	Low	X
T7	Group of 4 Willow, multi-stemmed with many dead branches.	None	Low	X
T8	Large, mature oak with holes, broken branches & loose bark. Thought to be under TPO.	None	High	✓

An assessment for bat potential was made of trees within the site that are not protected by the TPO (see Section 3.1.2, Habitat Survey – Broadleaved Woodland). Within the site itself, there are at least two mature trees (T1 & T8) with potential for bat roosts; both are oak with signs of decay, broken branches, loose bark, crevices and ivy. One of these trees is likely to be included within the TPO. A full bat survey was not carried out as it was beyond the scope of this study.

**5.1** If there is a requirement to remove trees T1 & T8 (or others identified at a later date) or to carry out any arboricultural work, in accordance with the BCT Bat Survey Protocol for Trees Affected by Arboriculture Work (See Appendix 3), two dusk emergence or pre-dawn re-entry survey should be undertaken for each affected tree between May to August (inclusive). If the tree is confirmed as being a bat roost, a Habitats Regulations licence will be required from Natural Resources Wales and the tree felled under the conditions stated within the licence. Similarly, if any of the trees protected by the TPO are likely to be felled or cut back, an assessment of the bat potential should be carried out together with further survey work where applicable.

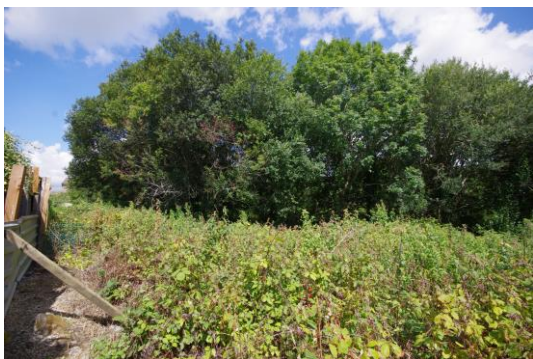
**Photo 9: Trees T2-7**

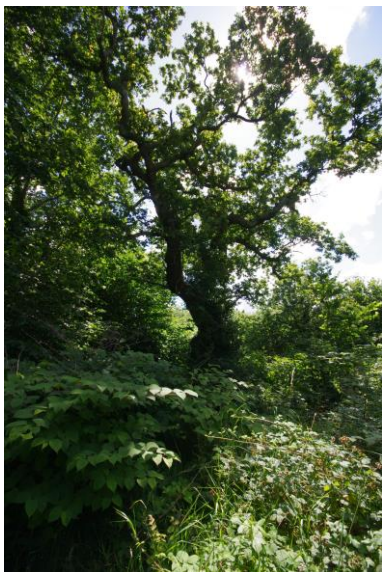
**Photo 10: Mature oak (T8) with Japanese Knotweed**
